## LEXAN BODIED SWIVEL BASES

## Swivel Base

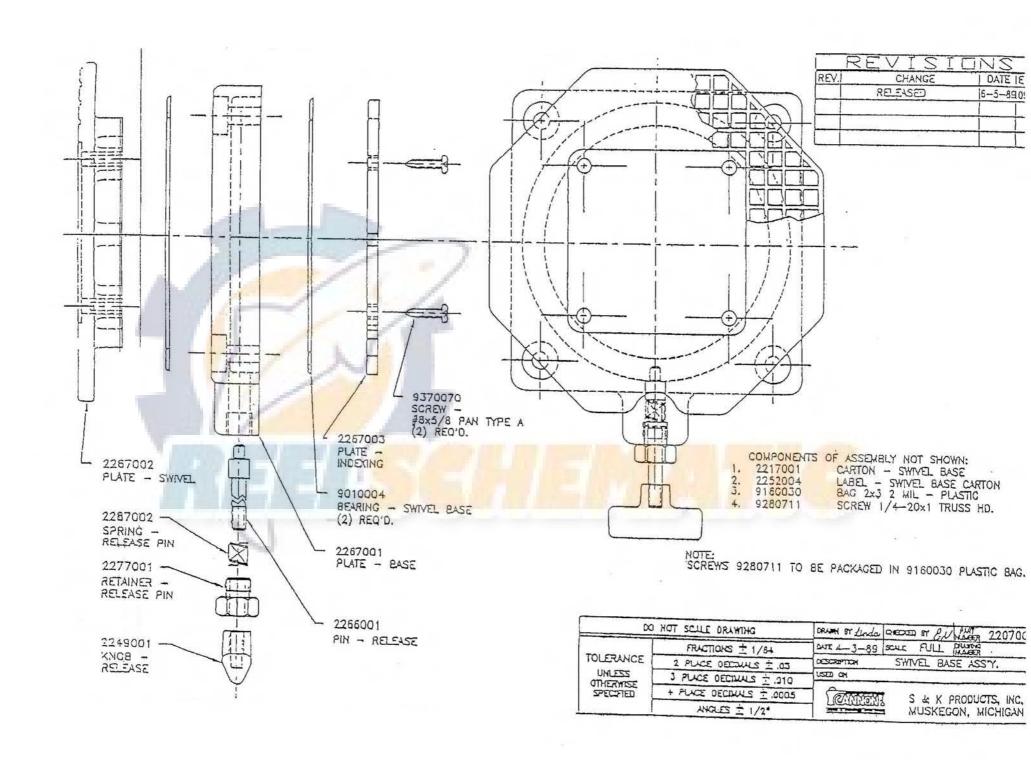
We have experieced a problem with the lock ring (C2898) popping loose, and in no case should the ring and washer be re-installed during service for other reasons. If the post has the offset hole drilled and tapped, the steel cap (C2922 and C2542) and screw may be retro-fit. If it doesn't have the hole, the post may be drilled using a 13/64 drill and 1/4-20 tap, using the hole in the steel cap as a drill locator.

Note: Parts C2422, C2180, C2059-1, and C2132 can only be ordered as a unit, C2180-A1.

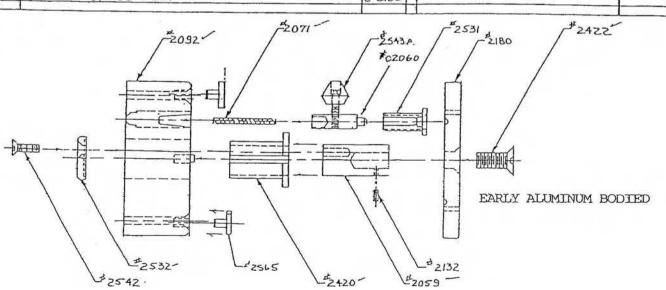
מדע	(SWIVEL BASE ASSEMBLY)	PART NO	40	(SWIVEL BASE ASSEMBLY CONT.	PART NO
1	POST STOP CAP - NYLON	C-2542	1	BEASS LOCE PIN HANDLE W/PIN	C-2543
1	SWILL BASE	505-7	11	HULOH GUIDE FOR LOCK PIN BASE PLATE	C-2180
i	NYLLON BEARING FOR BRASS PORT	1505-3	1	CAP SCREW 12-13 X14 F.H. SOCKET BLACK NYLON BUTTON BEARING	C-ZAZ
1	BEASS FOST	5-5025	1	LOCK PIN	C-2565
	PIN FOR BRASS POST	C-2132	Н		y III v. IZasac

The lock pin is made of brass and is designed to shear off if your rigger is rammed into something sufficent enough to do damage to it or your boat. New pins (C2060) made of stainless steel will have the same shear strength as the original brass pins.

The older model has a brass post assembly using mushroomed over flange securing the base plate to it. If this is damaged it cannot be repaired successfully and the complete swivel base must be replaced.

The cushion buttons (4) to stabilize the plate may be used to update older models and are placed near the center of the parallel sides, not at the corners.

Other changes such as, C2531 nylon guide for locking pin and nylon post stop cap (C2532) have been made to make this unit withstand looo hours of hot salt water spray test.
